Land at Ridgeway Lane and Lower Pennington Lane, Lymington

Pennington and Lymington Lanes Society

Road Safety Assessment

December 2021

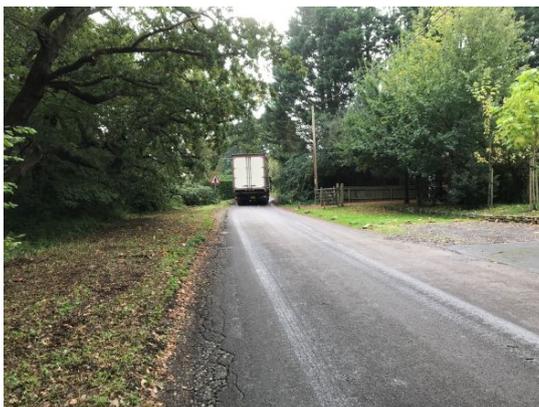
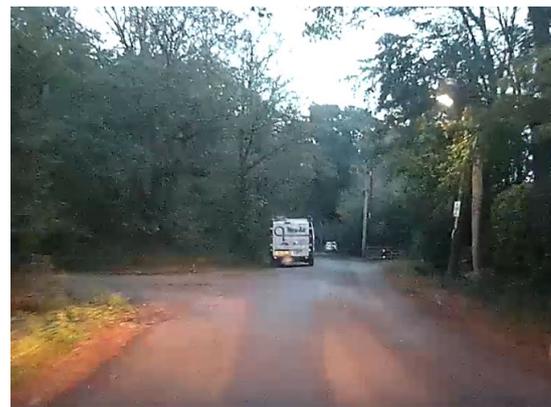
Risk 1: Assessment (Construction)

3.2.1 The trip generation and composition of traffic associated with the development of at least 84 houses, including additional large service and delivery vehicles along the narrow carriageways of Ridgeway Lane and Lower Pennington Lane will increase the risk of collisions with other road users. The large vehicles will occupy the majority of the carriageway as shown in the left hand image below. Car parking was observed on Ridgeway Lane adjacent to the Woodside Park car park as shown in the right hand image below and it is understood there can be a significant number of cars parked on the carriageway at weekends associated with sports/park run within the park. This further compromises the available road width and also forward and junction visibility.

3.2.2 It is unclear from the information provided how construction traffic would access the development during the construction stage. The size and number of construction vehicles would increase the risk of more frequent collisions and more severe injuries. The absence of a thorough and enforced construction management plan would increase the risk of collisions between construction vehicles and other existing road users.

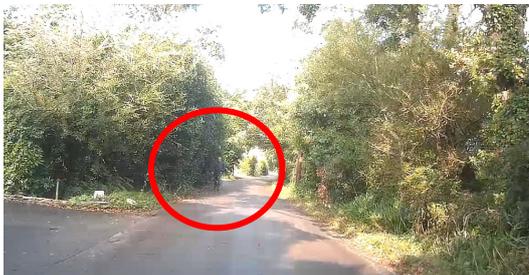
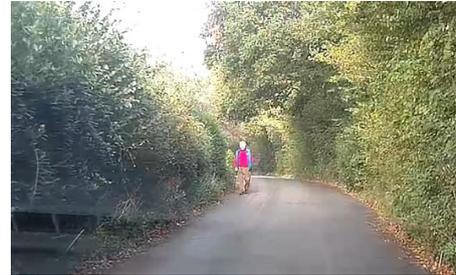
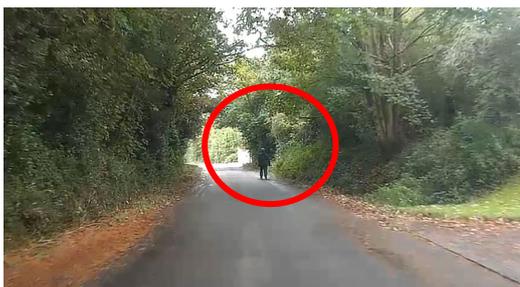
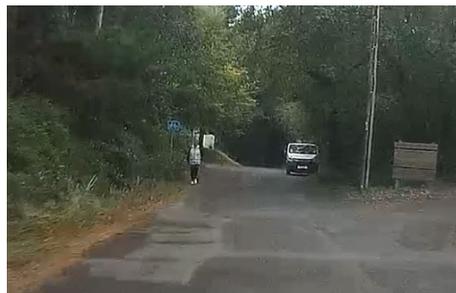
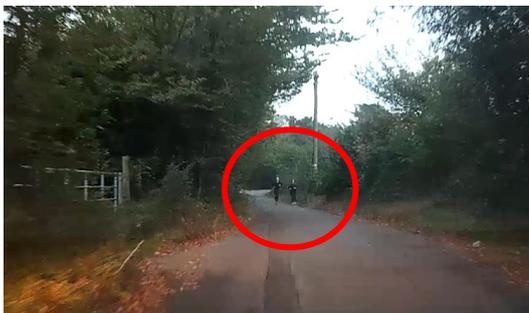
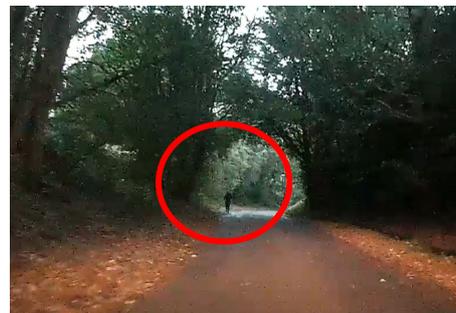
Risk 2: Increased risk of vehicle collisions with non-motorised users associated with increased traffic volumes and composition

3.2.3 Observations during the site inspection noted the high prevalence of non-motorised users sharing the carriageway with vehicles on Ridgeway Lane and Lower Pennington Lane, as shown in the images below. It can be difficult for other road users to see pedestrians walking or running on Ridgeway Lane and Lower Pennington Lane.

- 3.2.4 It is uncertain what is and what can be delivered in terms of a new footway on Ridgeway Lane between Forest Gate Garden and Rookes Lane. However, in any event the absence of footways or segregated cycle lanes on the remainder of Ridgeway Lane and Lower Pennington Lane would result in non-motorised road users travelling along the carriageway. For the pre-application scheme there is concern that the only pedestrian and cyclist access proposed on Lower Pennington Lane is at the south west corner of the site. The road safety is further compromised by vegetation, poor street lighting and on Ridgeway Lane at weekends, on-street car parking associated with activities in Woodside Park. Consequently, the risk of collisions between vehicles and non-motorised users particularly during the hours of darkness will be greater.

- 3.2.5 There is concern that the increase in the number of vehicle and non-motorised user movements along these roads associated with the development proposals would increase the risk of injuries to existing and future non-motorised road users.

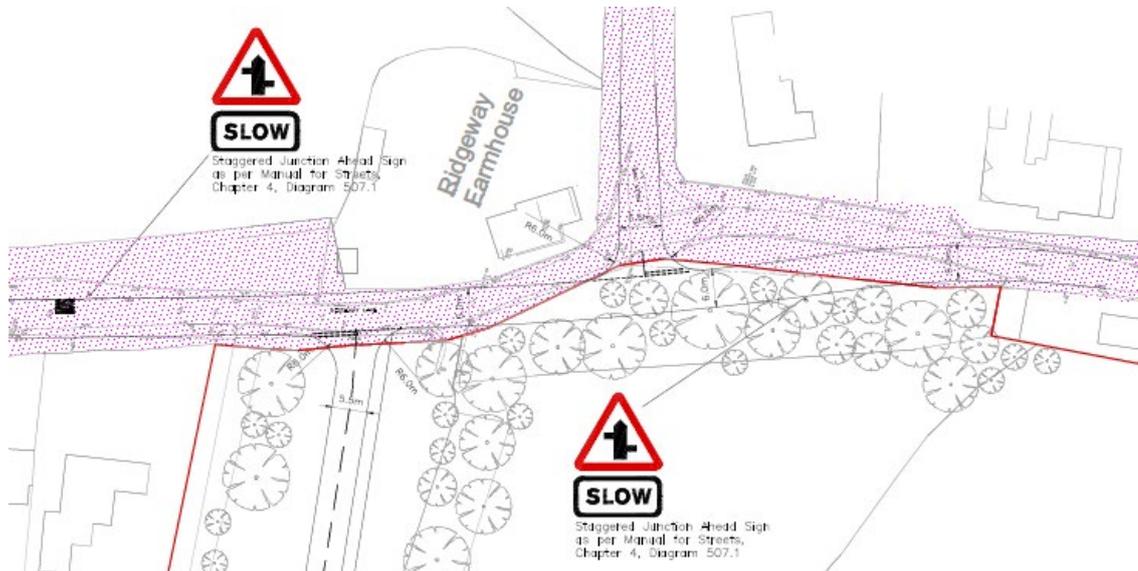
Risk 5: Assessment

3.2.8 The access to the proposed development on Ridgeway Lane involves the straightening and widening of the carriageway with staggered priority junctions for Poles Lane and the site access, as illustrated on the extract below. It was observed and understood that there are a large number of pedestrians walking north / south along Ridgeway Lane at this point, including to / from the Chequers Public House and the recreational paths along the coast.

3.2.9 The junction geometry, visibility and forward visibility on Ridgeway Lane would be provided to a more suitable standard, but there are no footways proposed and there is concern that the proposed arrangements would increase vehicle speeds on an unsuitable country lane between the Chequers public house to the south and Woodside Park in the north. This would increase the risk of collisions between vehicles and between vehicles and non-motorised road users and subsequent injuries to non-motorised users or vehicle occupants.

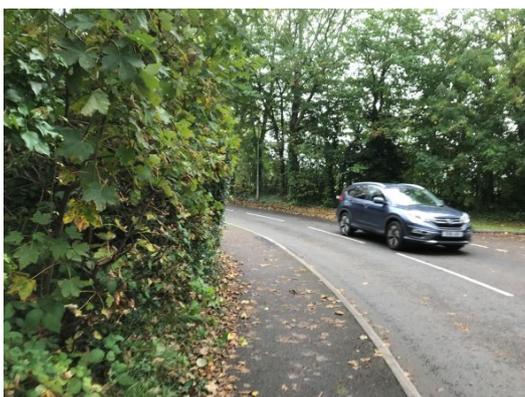
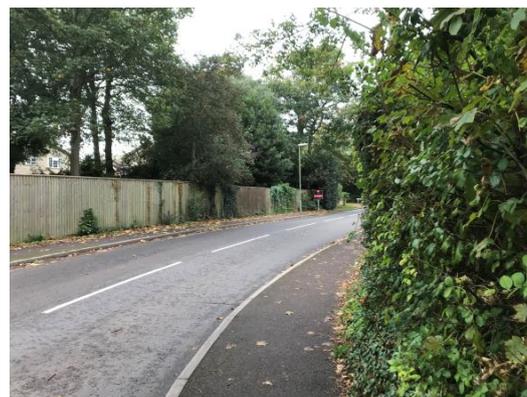
Risk 6: Increased risk of collision associated with insufficient visibility for pedestrians crossing at the Ridgeway Lane / Rookes Lane junction

3.2.10 There is a concern that the visibility for pedestrians using the dropped kerb crossing on Rookes Lane from east to west cannot see vehicles approaching from either direction and vice versa, due to the alignment of the road, as shown on the image below. With an increase in vehicles and pedestrians associated with the development using this junction and crossing there is an increased risk of an injury to a pedestrian if they step out into the path of an oncoming vehicle.

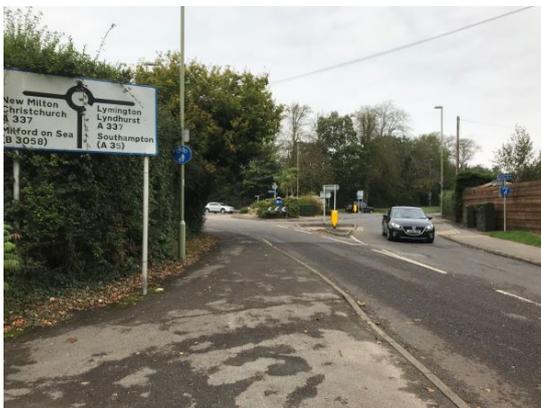
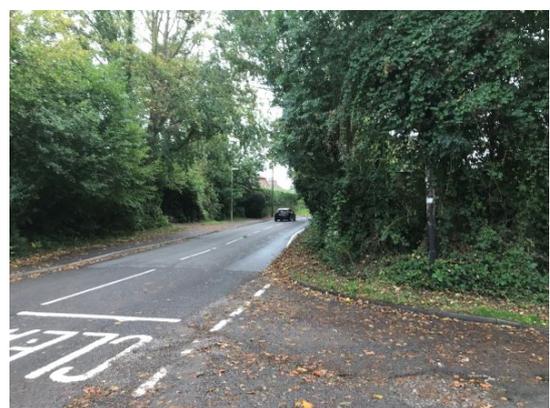
Risk 7: Increased risk of collisions due to insufficient visibility at Lower Pennington Lane / Ridgeway Lane Junction

3.2.11 There is a concern that there is insufficient visibility for drivers leaving Lower Pennington Lane to be able to see oncoming vehicles on Ridgeway Lane. Vegetation impedes the visibility to the right and to the left vehicles are leaving the A377 roundabout only some 30m from the junction, as shown on the images below. There is concern that the increase in the number of vehicle movements along these roads associated with the development proposals would increase the risk of collisions between vehicles and between vehicles, powered two wheelers and cyclists at this junction. Poor visibility may increase the risk of turning collisions or shunt type collisions as vehicles have to stop suddenly on the main road to avoid a collision with a turning vehicle. A combination of these factors may increase the risk of injury to vehicle occupants, users of powered two wheelers or cyclists.

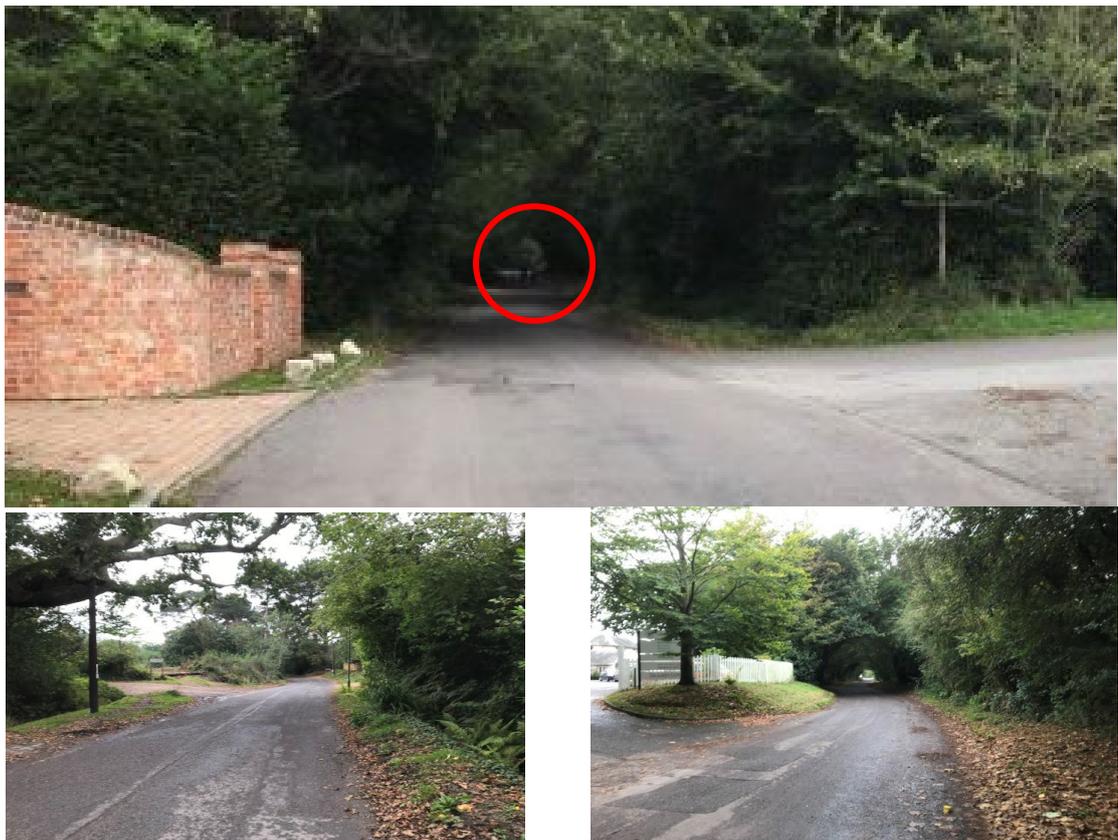
Risk 8: Assessment

- 3.2.12 The forward visibility to be able to see and react to oncoming vehicles and pedestrians on Lower Pennington Lane in the vicinity of Oakhaven Hospice as shown on the images below is severely constrained by the alignment of the road and overhanging vegetation creating a tunnel type effect. There is concern that an increase in the number of vehicle, pedestrian and cyclist movements at this point associated with the development would increase the risk of collisions between vehicles and between vehicles and non-motorised road users who would have insufficient time to see and react to oncoming vehicles or other road users. This risk of collisions during the hours of darkness would be greater. A combination of these factors may increase the risk of injury to vehicle occupants, users of powered two wheelers or non-motorised users.

- 3.2.13 There is a particular concern with the pre-application scheme as the only pedestrian and cyclist access proposed on Lower Pennington Lane is at the south west corner of the site. All road users would have to use this section of Lower Pennington Lane past Oakhaven Hospice, although some pedestrians may use footpath 83 to the north west of the site to / from Lower Pennington Lane, but this would not be suitable for all as it is a muddy track / path.

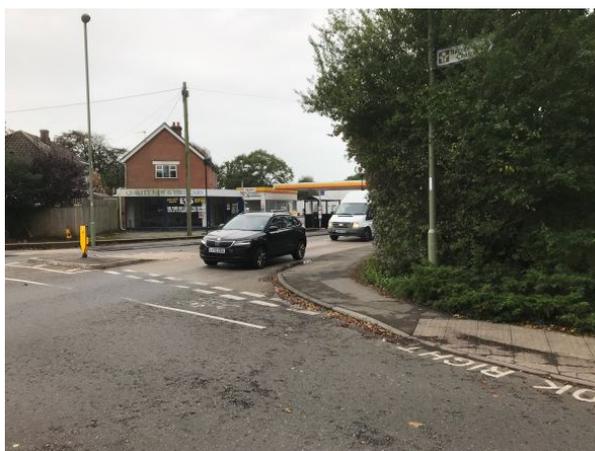
Risk 11: Increased risk of collision associated with insufficient visibility for pedestrians crossing at the A337 / North Street / Ridgeway Lane roundabout

3.2.16 There is a concern that the visibility for pedestrians crossing North Street at the roundabout from west to east cannot see turning vehicles from the A337 eastbound and vice versa, due to overgrown vegetation leaving Lower Pennington Lane to be able to see oncoming cars on Ridgeway Lane as shown on the image below. With an increase in vehicles and also pedestrians associated with the development using this junction and crossing, the poor visibility may increase the risk of pedestrians stepping out into the path of turning vehicle increasing the risk of injury to pedestrians.

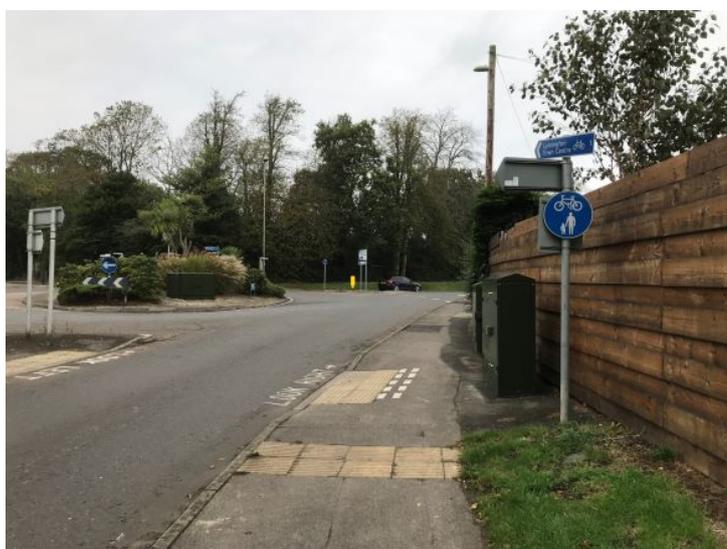
Risk 13: Increased risk of collision associated with inconsistent cyclist facilities at the A377 / North Street / Ridgeway Lane roundabout

3.2.18 There is a concern that there is inconsistent and confusing cyclist provision at the roundabout, including a combination of on-road cycle lanes and off-road shared footway / cycleway provision. The off-road shared footway / cycleway provision is also too narrow to safely allow pedestrians and cyclists to pass freely, as shown on the image below. Pedestrians or cyclists may be forced onto the carriageway. There have been three accidents at this junction involving cyclists within the last five years, including one serious injury. There is an increased risk of collisions between cyclists, cyclist and pedestrians and cyclists and vehicles, with an increase in these movements using the junction to access local facilities and amenities associated with the development. This could increase the risk of injuries to cyclists and pedestrians.
