Land at Ridgeway Lane and Lower Pennington Lane, Lymington

Pennington and Lymington Lanes Society

Road Safety Assessment

December 2021

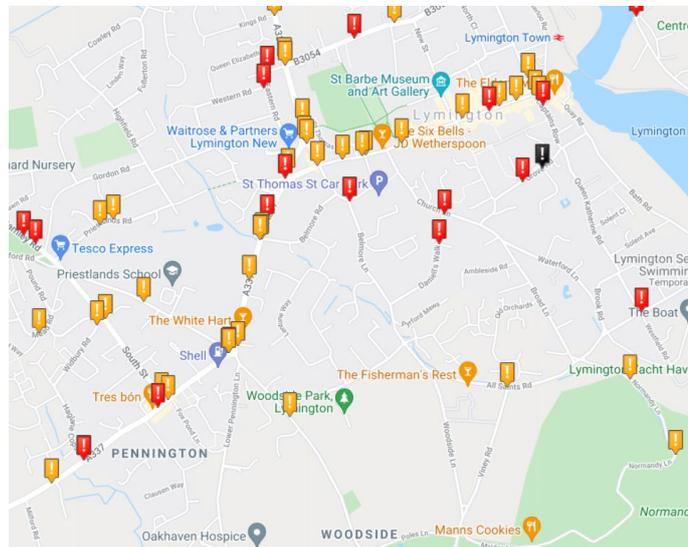
Figure 1: Location of all reported collisions five-years up to December 2020

2.10.1 Crashmap has been interrogated for the latest five-year period within the study area. The Crashmap data is approved by the National Statistics Authority and is reported on by the Department for Transport each year. Figure 1 shows the location of the accidents reported within the most recent five-year period up to December 2020.

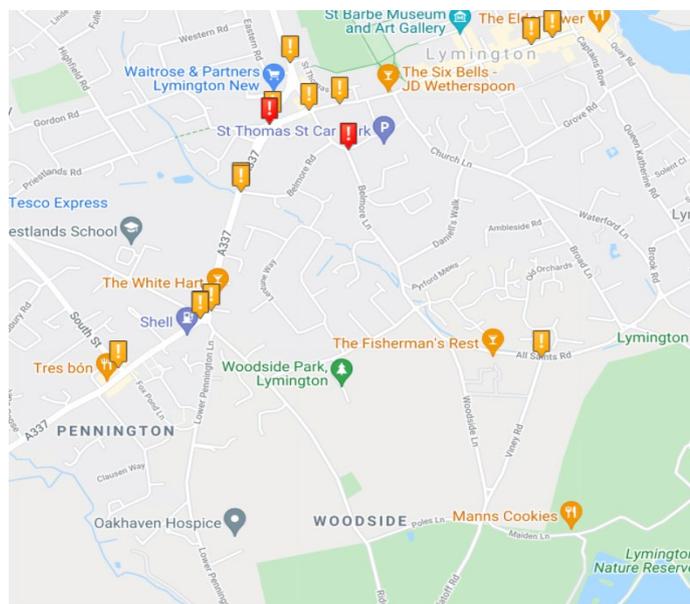
Figure 2: Location of all reported pedestrian/cyclists collisions five-years up to December 2020

2.10.2 A further review of Crashmap has been carried out to identify the accidents involving pedestrians, cyclists and other non-vehicle users. Figure 2 below shows the location of the pedal cyclist casualties within the last five years.

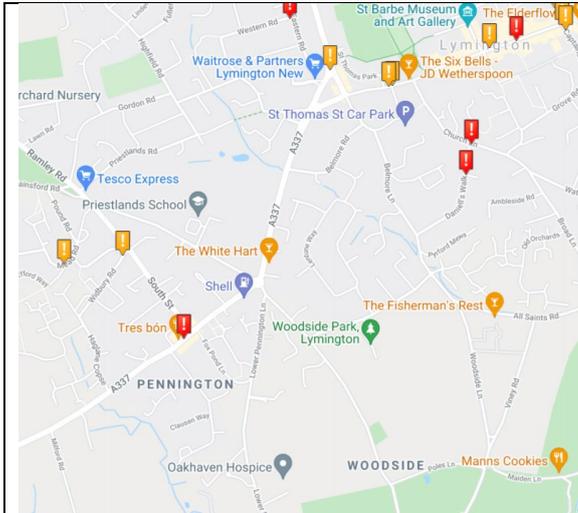
Figure 3: All reported pedestrian collisions recorded for the five-year period up to December 2020

2.10.3 Figures 3 and 4 respectively show the location of collisions involving all pedestrians and children casualties within the last five years.

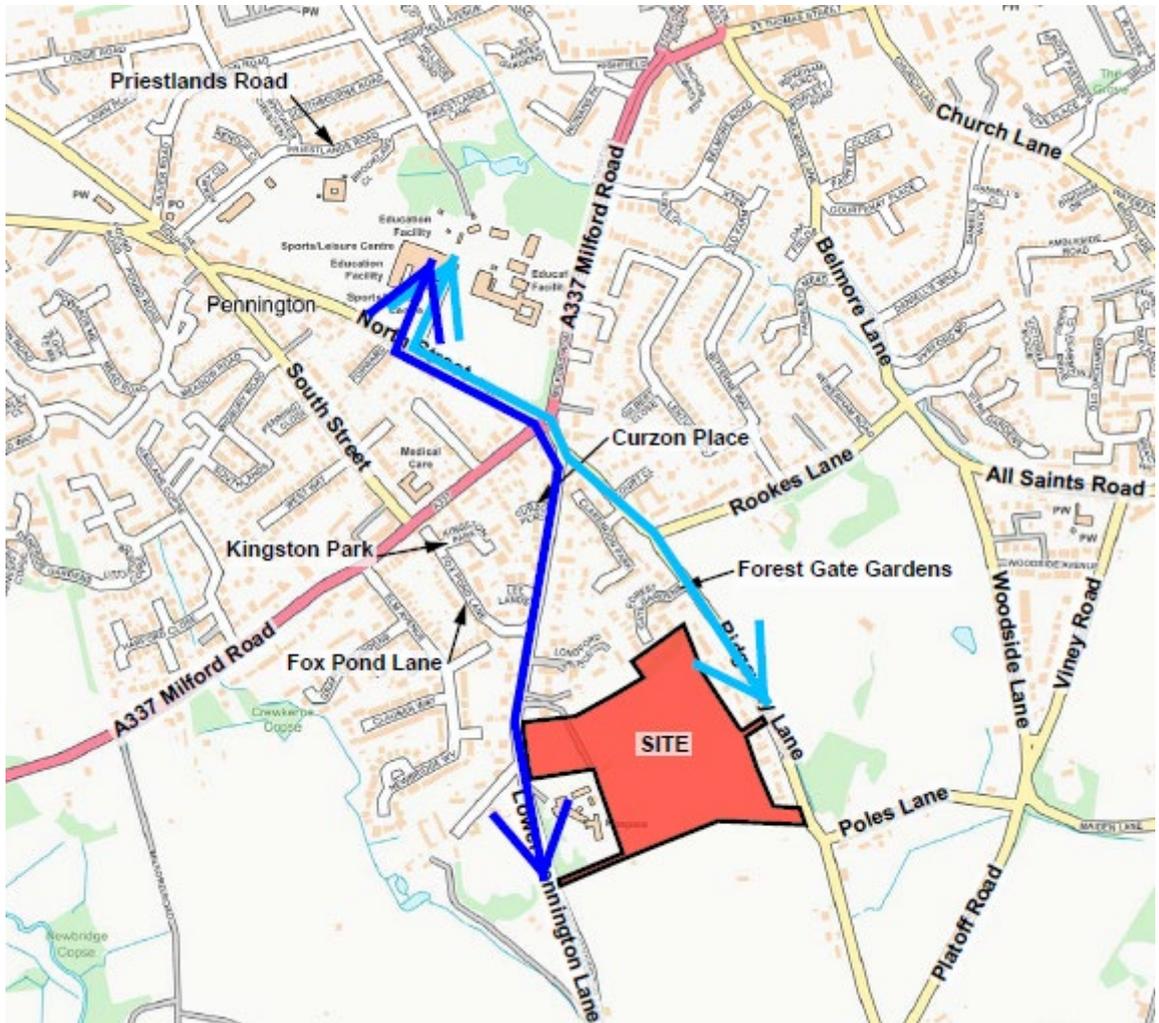
WALKING TO PRIESTLANDS SCHOOL AND LYMINGTON HEALTH & LEISURE CENTRE				
Via Ridgeway Lane				
Attractiveness	Comfort	Directness	Inclusive	Safety
Ridgeway Lane not attractive to walk in darkness and in wet weather conditions	No footways on Ridgeway Lane	Necessary to cross Ridgeway Lane north of Rookes Lane and A337 at roundabout	Unattractive and uncomfortable route on Ridgeway Lane would impact on vulnerable users, including young children, aged and disabled people, people with pushchairs etc	Risks No. 2, 3, 8, 9 10 and 11
Lack of active frontages, no natural surveillance, poor street lighting on Ridgeway Lane	Crossing busy A337. High levels of noise and pollution		Unattractive and uncomfortable route on Ridgeway Lane would increase fear of crime and intimidation	
North Street generally satisfactory	North Street generally satisfactory		North Street generally satisfactory	
Via Lower Pennington Lane

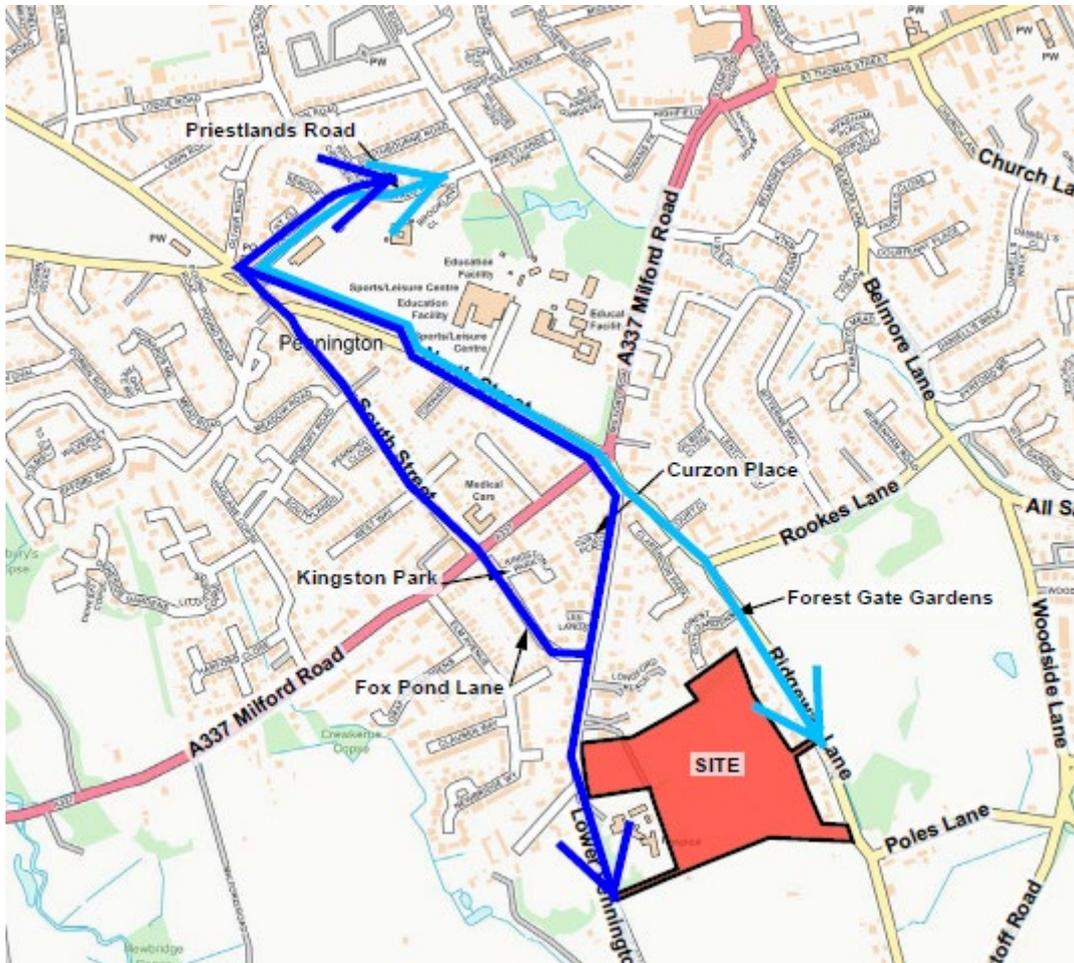
WALKING TO PENNINGTON INFANT AND JUNIOR SCHOOL / PENNINGTON LOCAL SHOPS				
Attractiveness	Comfort	Directness	Inclusive	Safety
Via Ridgeway Lane				
Ridgeway Lane not attractive to walk in darkness and in wet weather conditions	No footways on Ridgeway Lane	Necessary to cross Ridgeway Lane north of Rookes Lane and A337 at roundabout	Unattractive and uncomfortable route on Ridgeway Lane would impact on vulnerable users, including aged and disabled people, people with pushchairs	Risks No. 2, 3, 5, 6 and 11
Lack of active frontages, no natural surveillance, poor street lighting on Ridgeway Lane	Crossing busy A337. High levels of noise and pollution		Fear of crime and intimidation due to insufficient infrastructure and natural surveillance particularly on Ridgeway Lane	
North Street and Priestlands Road generally satisfactory	North Street and Priestlands Road generally satisfactory		North Street and Priestlands Road satisfactory although some users would not be comfortable using the segregated path between North Street and Priestlands Road

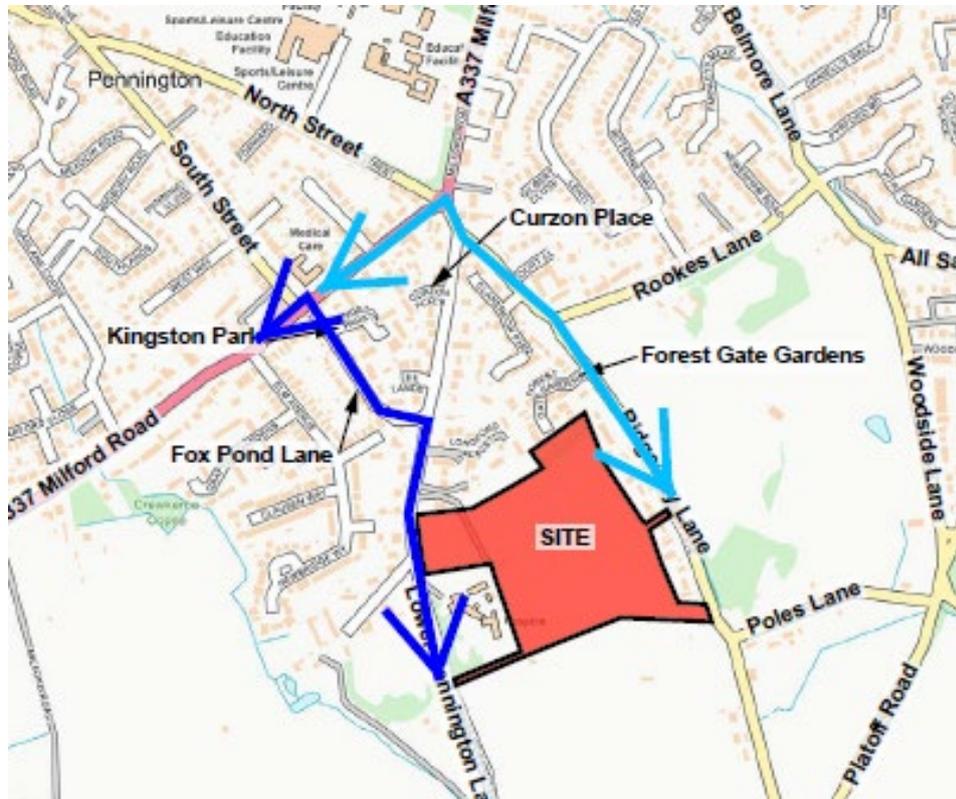
WALKING TO LOCAL SHOPS / BUS STOPS ON A337				
Attractiveness	Comfort	Directness	Inclusive	Safety
Via Ridgeway Lane				
Ridgeway Lane not attractive to walk in darkness and in wet weather conditions	No footways on Ridgeway Lane	Necessary to cross Ridgeway Lane north of Rookes Lane and A337 at roundabout	Unattractive and uncomfortable route on Ridgeway Lane would impact on vulnerable users, including aged and disabled people, people with pushchairs	Risks No. 2, 3, 5, 6, 10, 11 and 12
Lack of active frontages, no natural surveillance, poor street lighting on Ridgeway Lane	Crossing busy A337		Fear of crime and intimidation due to insufficient infrastructure and natural surveillance particularly on Ridgeway Lane	
	Footways on A377 narrow and high traffic and noise levels		No tactile paving at side road junctions on A337 including at South Street and North Greenlands junctions	
			Wide crossing of petrol filling station

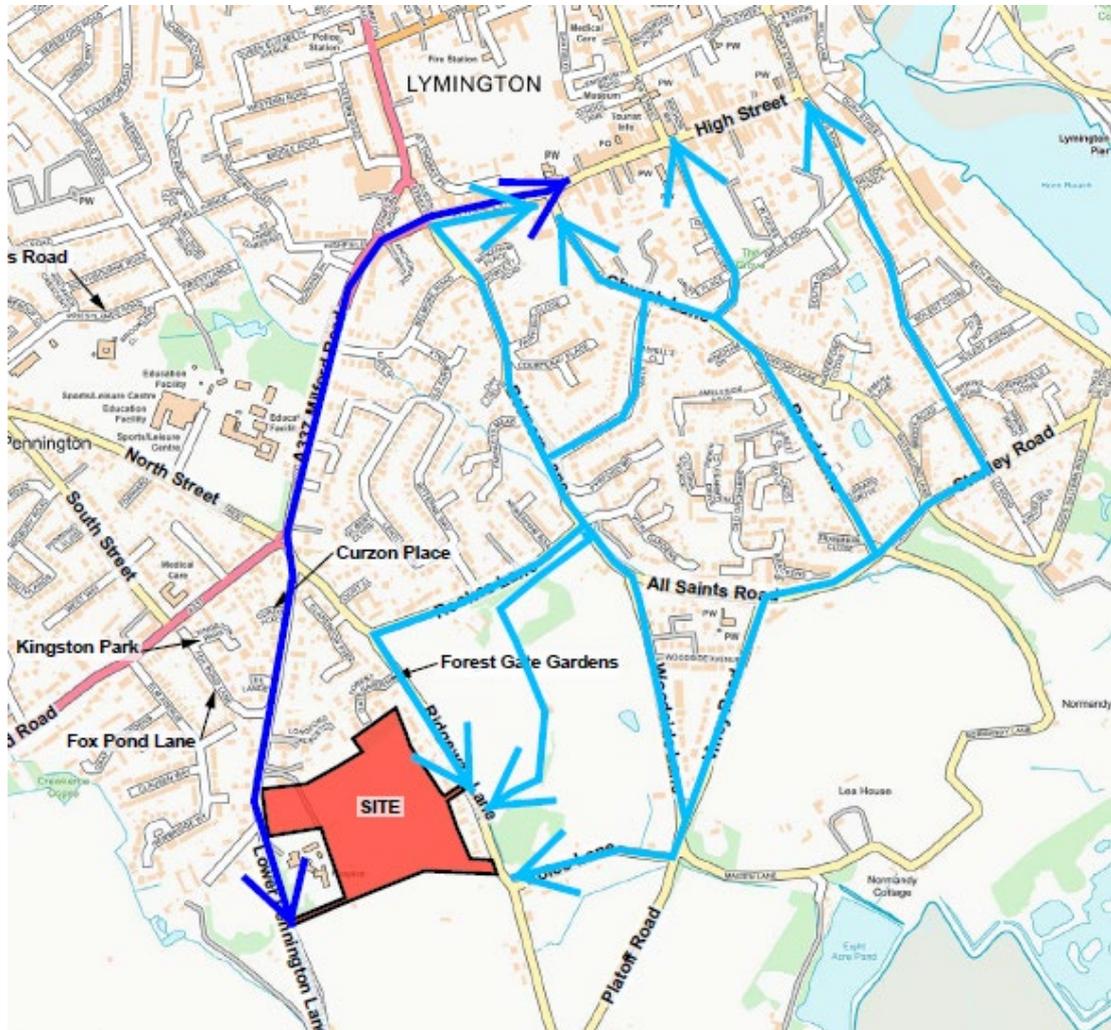
WALKING TO TOWN CENTRE				
Attractiveness	Comfort	Directness	Inclusive	Safety
Via Ridgeway Lane				
Ridgeway Lane and Poles Lane not attractive to walk in darkness and in wet weather conditions	No footways on Ridgeway Lane, Poles Lane Woodside Lane, Viney Road	No direct route to town centre	Unattractive and uncomfortable route on Ridgeway Lane, Poles Lane and through Woodside Park would impact on vulnerable users, including aged and disabled people, people with pushchairs	Risks No. 2, 3, 5, 6, 10
Lack of active frontages, no natural surveillance, poor street lighting on Ridgeway Lane, Poles Lane and through Woodside Park	All Saints Road and roads to town centre generally satisfactory	Numerous roads to cross	Fear of crime and intimidation due to insufficient infrastructure and natural surveillance particularly on Ridgeway Lane, Poles Lane and through Woodside Park	
All Saints Road and roads to town centre generally satisfactory	Uphill gradient to town centre		Generally no tactile paving at junctions between site and town centre
